# FIRE RISK ASSESSMENT

## Beeston Hall School - Main Block & Music Block

Beeston Hall School - Main Block & Music Block,  
West Runton, Cromer, Norfolk, NR27 9NQ

VALID BETWEEN	17/10/2022 - 17/10/2023
ASSESSED BY	Charlie Brough MIFSM, CFRAR
ASSESSED ON	17/10/2022
APPROVED BY	Michael Wells TIFSM
APPROVED ON	02/11/2022
ASSESSMENT REF.	RB-R9N8WH
VERSION	1

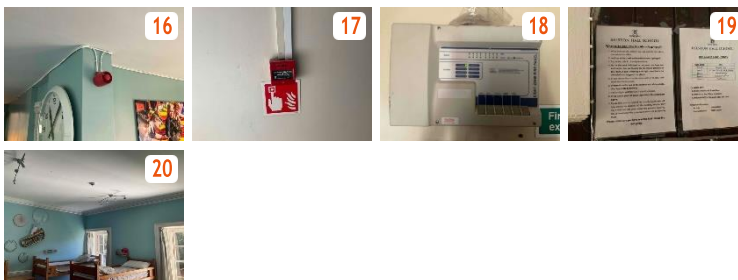
**LOCATION** Throughout the site

**WHY** The main block is equipped with an automatic fire alarm system. The precise category of the system could not be confirmed as it differs around the site. There were areas where no fire detection was present and were considered risk rooms, such as the drawing room and directly outside the drawing room, which is part of the escape route and within the rear of the kitchen escape route. The alarm system is configured for a simultaneous activation and is addressable. Manual call points are located on each floor level and final exits. The main fire alarm panel indicated no faults or warnings at the time of the assessment, and a zone chart was fixed adjacent to the panel.

- There is a requirement to upgrade the automatic fire detection and alarm system in accordance with BS 5839-1:2017 to category L1. This will ensure all rooms and escape routes are protected and will give adequate time of warning for staff to evacuate students during the day and night time while students are sleeping.

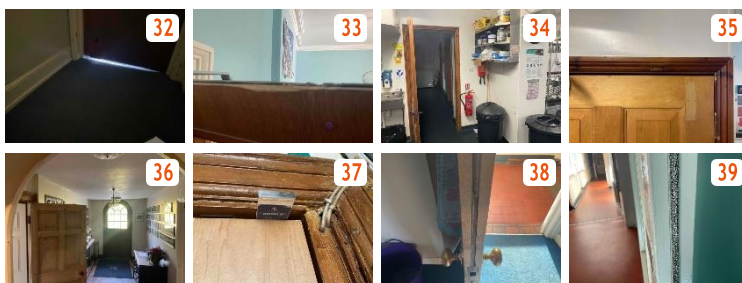
LOCATION Throughout

WHY During the assessment, it was noted that throughout the building, there are several issues found with the fire doors, such as;

- Various fire doors have excessive gaps,
- Damaged smoke seals and missing intumescent strips were observed,
- Where installed, cold smoke seals have been painted over,
- Student bedroom fire doors were damaged,
- Self-closing devices missing from doors leading onto the escape route and from high-risk rooms.
- Fire door signage missing.

During the assessment, it was noted that throughout the building, there are several issues found with the fire doors, such as;

- Due to the number of deficiencies found, it is recommended that a complete fire door survey is undertaken and appropriate remedial works carried out to ensure they function as intended. This should include their fire resistance and smoke control suitability and if replacement door sets are required.

Due to the number of deficiencies found, it is recommended that a complete fire door survey is undertaken, and appropriate remedial works carried out to ensure they function as intended. This should include their fire resistance and smoke control suitability and if replacement door sets are required.

A full check of all doors has been carried out and remedial works planned where necessary. A check has also been carried out of all fire signage and any missing signs have been replaced.
