# FIRE RISK ASSESSMENT

## Beeston Hall School - Swindells, Pre-Prep, Teaching Block, Art & DT and Out Blds

ASSESSMENT AND CERTIFICATE REFERENCE  
RB-IENKYD

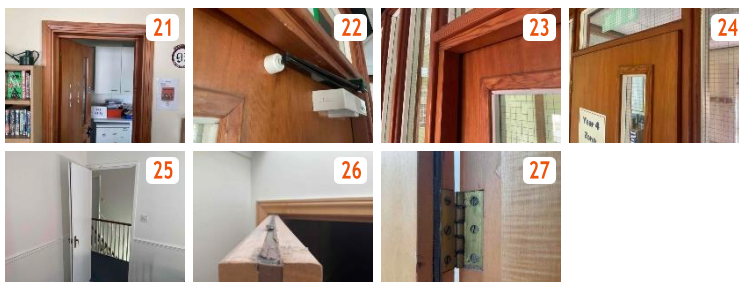
WHY During the assessment, it was noted that throughout the outer buildings, a number of issues were found with the fire doors, such as;

- Various fire doors have excessive gaps between the door leaf or between the leading edge of the door and the door frame.
- Damaged smoke seals and missing intumescent strips were observed,
- Self-closing devices missing from doors leading onto the escape route and from high-risk rooms.
- Fire door signage

LOCATION Throughout the outer buildings

- Due to the number of deficiencies found, it is recommended that a complete fire door survey is undertaken and appropriate remedial works carried out to ensure they function as intended. This should include their fire resistance and smoke control suitability and if replacement door sets are required.
